Out of Gas!

The Incident

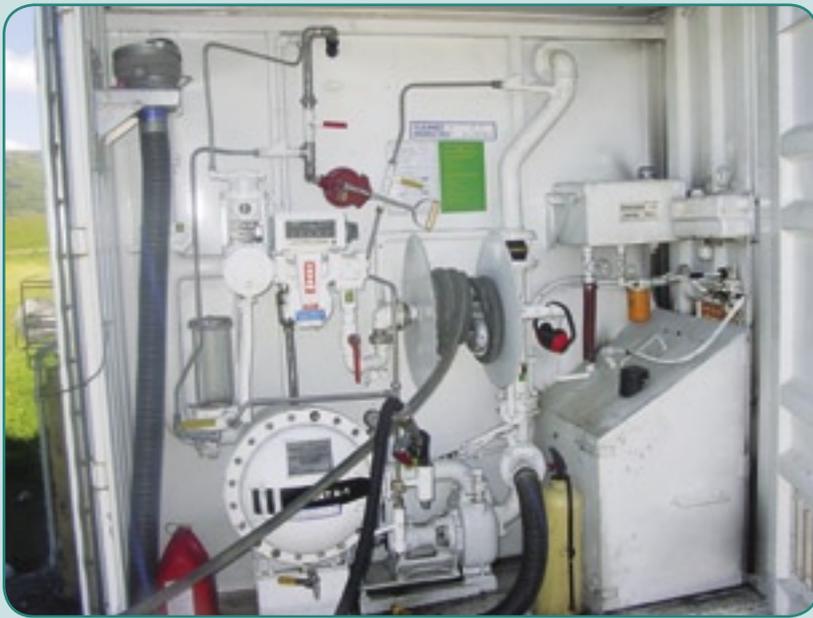
The high-flow fuel pump system used to refuel the incident aircraft. This system is capable of delivering fuel at a significantly higher rate than the standard fuel pumps found at most aerodromes.

At normal fuel pump flow rates, there is usually sufficient time for the tanks to equalise at the same rate as the fuel is being pumped in. With a high-flow fuel pump (such as was used to refuel this aircraft), the tanks can not equalise at the same rate as the fuel is being pumped in. The outboard tanks will

consequently fill before the inboards. This can lead the person refuelling to believe that the inboard tanks are also full.

- Pilots and operators of aircraft with interconnected fuel tanks need to be aware that fuel transfer problems can develop when refuelling with high-flow fuel pumps. We suggest that the fuel be delivered using a medium-flow type fuel pump, or that each tank be given time to settle before being topped up, ie, fuel one side then come back to top it up after having fuelled the other side.
