Fuel Starvation with Quarter Tanks?

The Incident

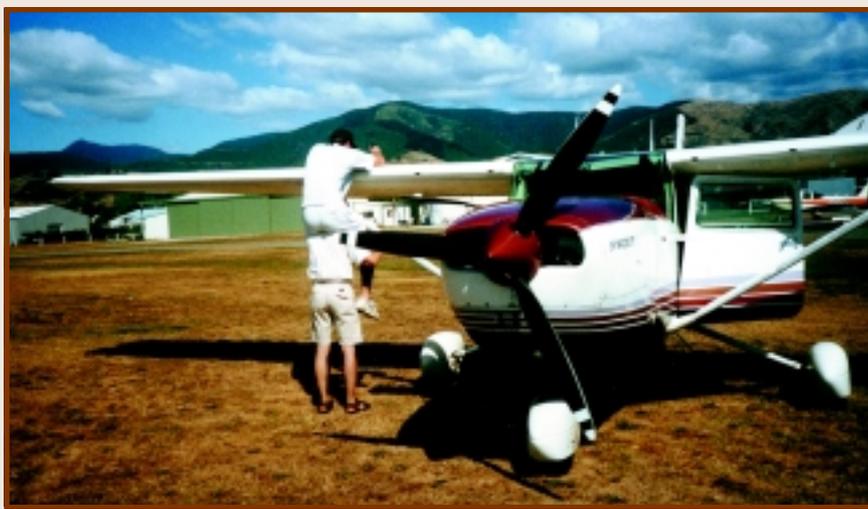
The aircraft involved is a Cessna 180B model, which has only one fuel outlet per tank, located about the mid-point on the inboard edge of each tank. Prolonged sideslip, or steep descent, with low fuel quantities can unport the fuel outlet and cause fuel starvation to the engine. C180E and subsequent models have two outlets per tank, one forward and one aft, and are not subject to the same problem. The two tank outlets on the C180E and subsequent models reduce the unusable fuel quantity to 18 litres compared with 36 litres for the earlier models.
